No More Slapping!

March 29, 2013 | We were eagerly anticipating our first night at anchor in our new Eagle 40, *Mischief*. Imagine, a real double bed instead of the cramped v-berth we were used to in our former sailboat. But our reverie was interrupted by a persistent slap, slap ... slap, slap, slap against the hull right in our berth; sometimes on the starboard side, sometimes on port. We couldn't hear it from any other place on the boat, just the berth.

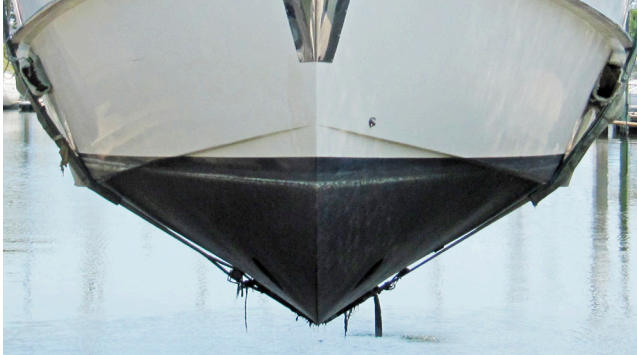
Before, with hard chines

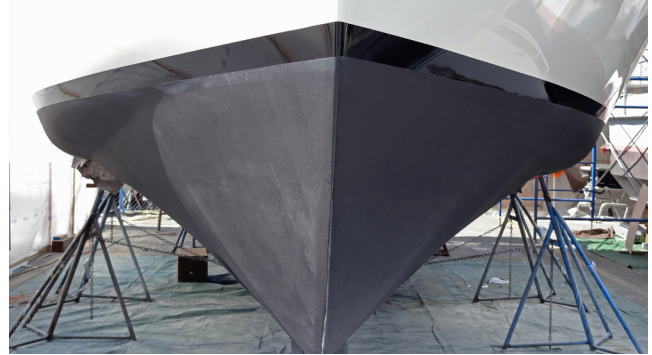
Rounded chine with bottom paint

topsides. Below that they did an epoxy barrier coat then a new boot stripe and bottom paint.

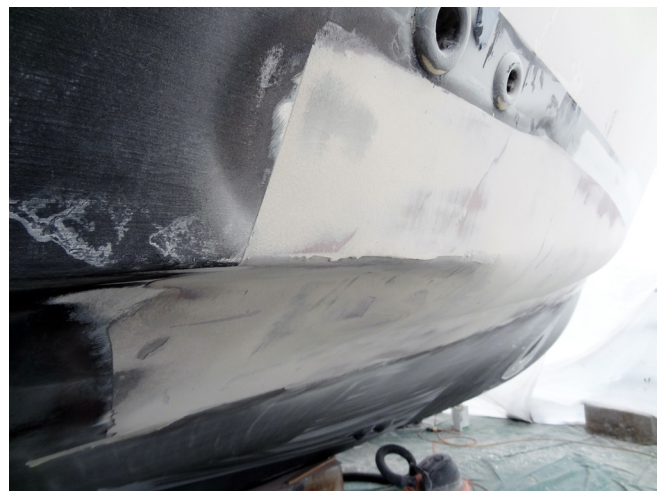
Transition from hard chine to rounded chine

So I found a respected fiberglass company in the area and described what I wanted to do. They probably thought I was crazy and gave me a large estimate. But I said, go ahead. They would start the rounding where the chine was about six inches below the waterline and for esthetic reasons, extend the rounding all the way to the bow. They chose to do the filling by using bending plywood (with lots of holes drilled in it) to make a form by pressing the plywood to the hull above the chine and again to the hull a ways below then filling the form with high density expanding foam. After

removing the plywood they would fair the foam to the hull and then cover it in multiple layers of glass cloth, overlapping to spread loads. After a final fairing they sprayed matching gel coat for the

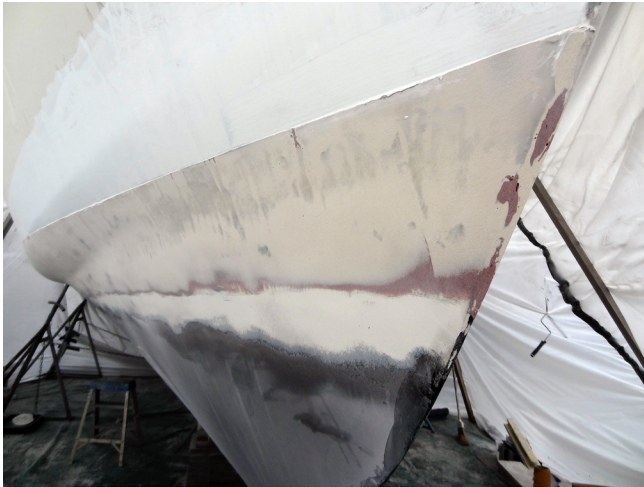
Rounded chine after sculpting

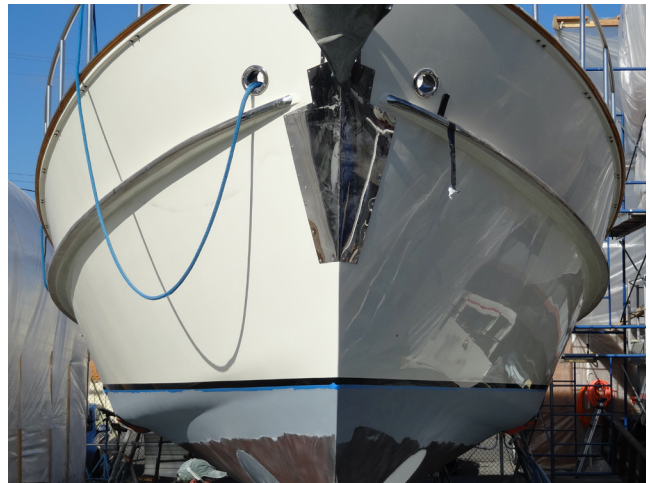
Rounded chine with epoxy barrier coat

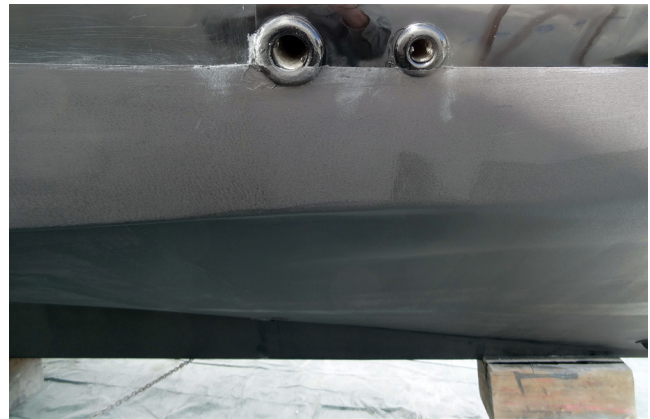
Finished chine transition from hard to rounded

How did it turn out? It was the single best thing we ever did to the boat. The boat is totally immune to the dreaded slap, slap, slap and even larger wave impact sound is greatly reduced. The only time we hear waves in the berth is when they are coming from the side, which is rare at anchor but sometimes happens at a dock. It was worth every penny and we would recommend the change for every Eagle owner, despite the cost. It makes all the difference.
